**Flood Control Project Maintenance
Levee Inspections**

Maintenance Issue Types Only, Levee Inspection Report By Mile - Spring 2017

Reclamation District No. 0551 Pearson

| Waterway | Bank | Unit Miles | Inspection Start/End | Inspector |
|---|---|---|---|---|
| Unit No. 01 Sacramento River | Left | 6.78 | 04/06/2017 04/06/2017 | Herman Phillips |

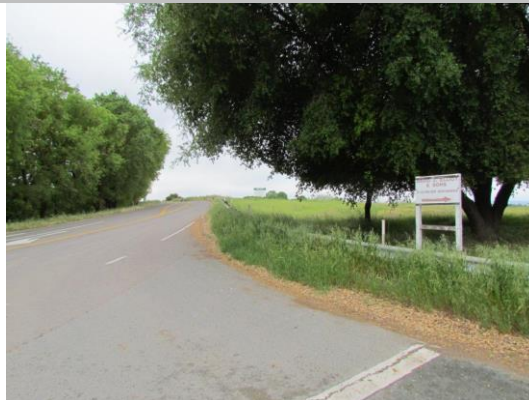
Photo 1 of 1 : SP_2017_RD0551_175_18_20170410_00037.jpg

| Control the weed growth on the waterside levee slope. | | | | | |

Levee mile 0.00 looking downstream waterside levee slope.

| V1 : Control annual grass and weeds on the levee slopes and easements. | | | | | |

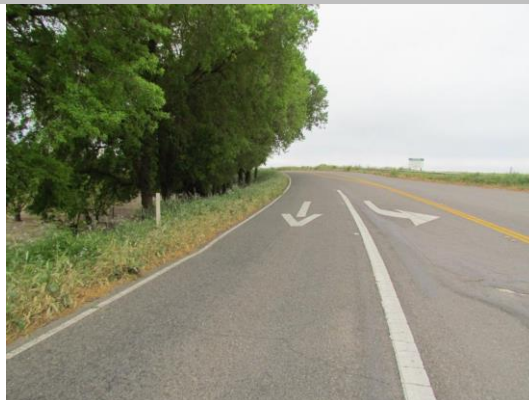
Photo 1 of 1 : SP_2017_RD0551_175_17_20170410_00038.jpg

| Control the weeds and annual grass growth on the landside levee slope. | | | | | |

Looking downstream at the landside levee slope.

| V1 : Control annual grass and weeds on the levee slopes and easements. | | | | | |

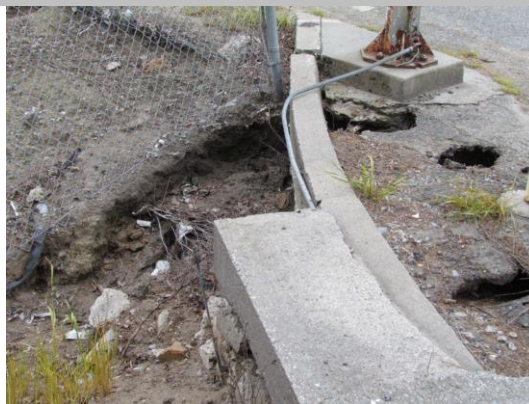
Photo 1 of 3 : SP_2017_RD0551_175_25_20170410_00039.jpg

| This erosion was discovered by the property owner during the Feb 2017 Storm event Mr. Tony of Tony's Market Courtland Ca. It was brought to our attention during this Spring inspection 4-06-2017. | | | | | |

From landside standing North of erosion. The concrete footing is being undermined.

| E2 : Schedule repair of erosion site prior to the next inspection. | | | | | |

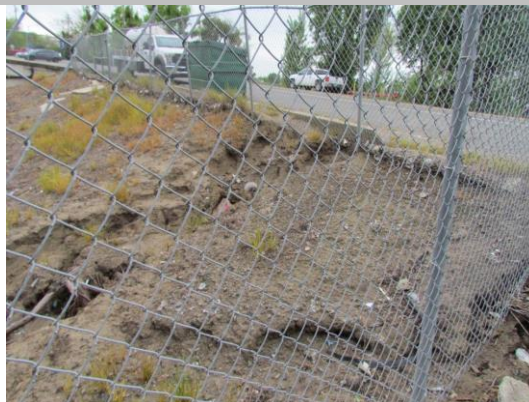
Photo 2 of 3 : SP_2017_RD0551_175_25_20170410_00040.jpg

Standing on the shoulder North of the eroded slope looking downstream of slope.

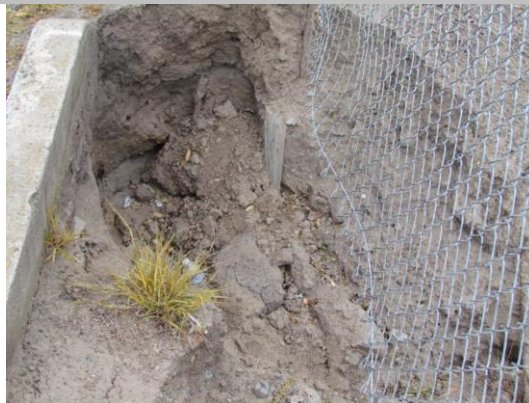
Photo 3 of 3 : SP_2017_RD0551_175_25_20170410_00041.jpg

| This erosion was discovered by the property owner during the Feb 2017 Storm event Mr. Tony of Tony's Market Courtland Ca. It was brought to our attention during this Spring inspection 4-06-2017. | | | | | | |

Standing south of the eroded slope looking upstream. The cut is 3 foot deep and 6 foot wide.

| E2 : Schedule repair of erosion site prior to the next inspection. | | | | | | |
